Performance Analysis of Aged TPO Membranes

**IIBEC 2020 Virtual International
Convention and Trade Show
June 12-14, 2020**

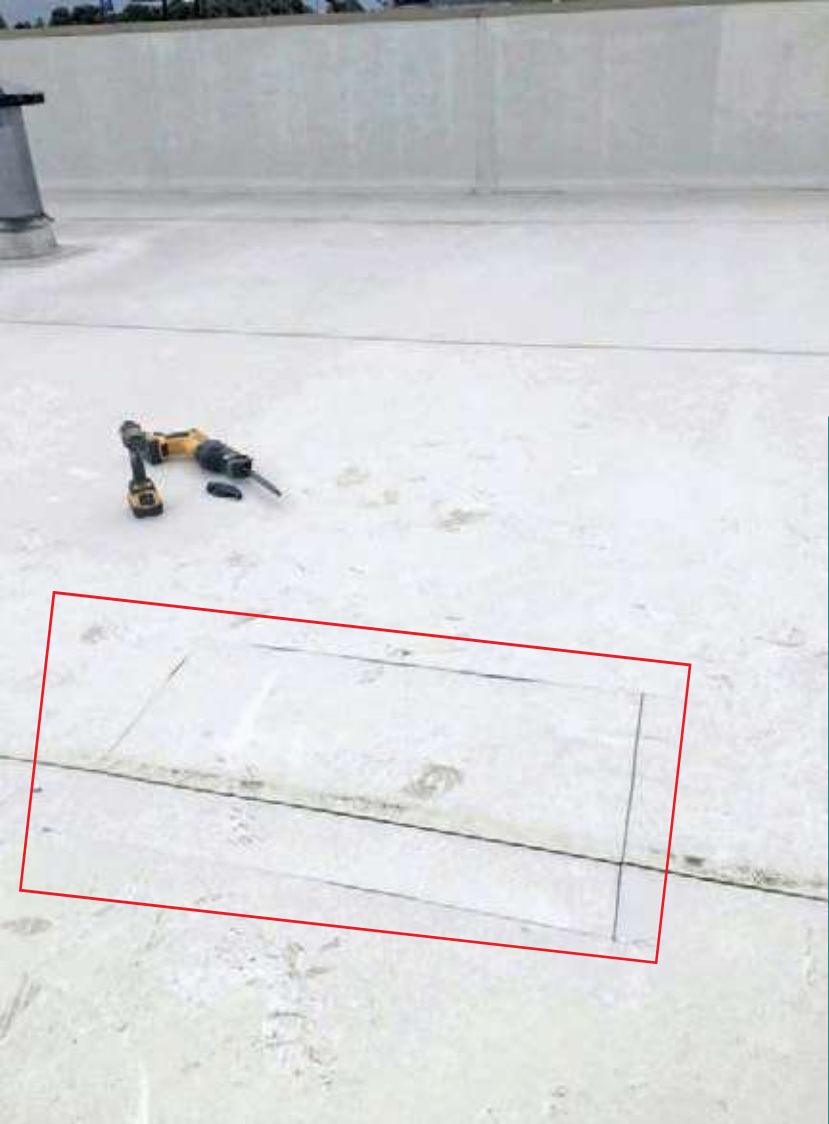
Figure 1 – Typical 2- x 3-ft. field sample.

Two samples were taken from each roof. Each sample was 2 by 3 ft. and captured a field-welded seam. One sample was taken from the field of the roof (see *Figure 1*), and the other was taken in a location that resulted in increased heat exposure (see *Figure 2*). To date, the increased heat-exposed samples were located adjacent to the north parapet wall. In the future, this ongoing study will include areas where sunlight reflects off adjacent glazing or metal.

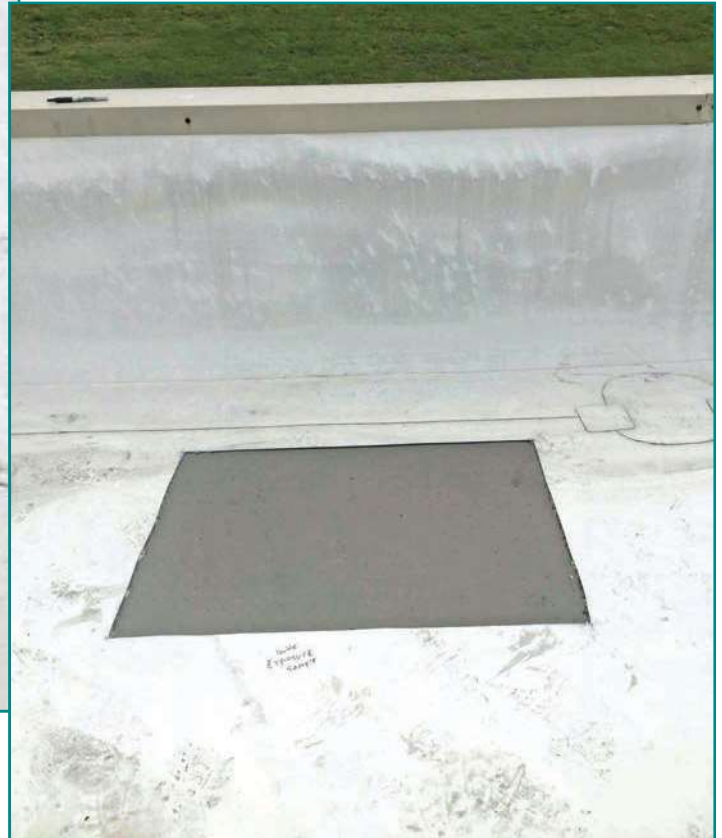
Figure 2 – Typical north parapet, 30 inches in height.

To date, the increased heat exposure samples have been limited to the membrane adjacent to the north parapet wall. No measurable differences in performance between field and increased heat-exposed samples have been observed. However, it is hoped that samples that have been subjected to a harsher exposure, such as reflection from glass or metal from an adjacent building, can be located.

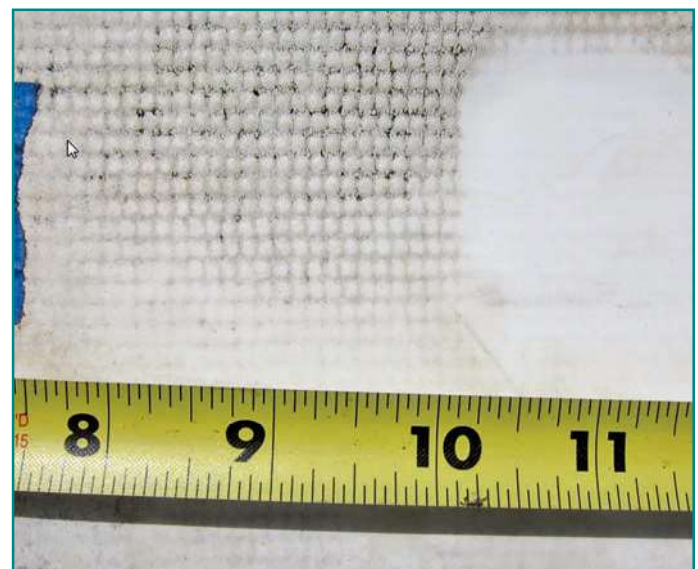
formance, as it provides the UV and heat stabilization properties of the membrane. As the cap erodes, the scrim can become exposed and the weathertightness of the membrane is then compromised, as shown in *Figure 7*.

Figure 7 - Premature failure as cap erodes and exposes scrim. Image courtesy of René Dupuis.

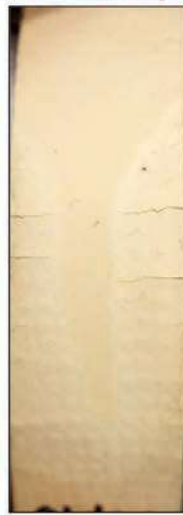
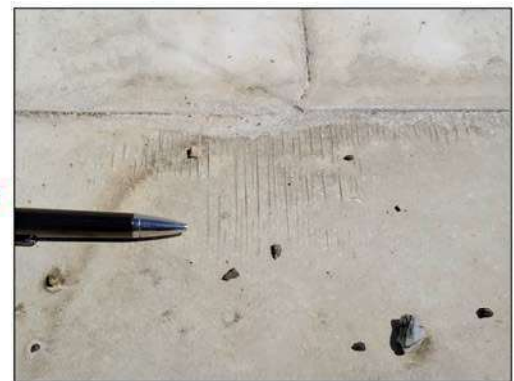
Figure 9 – Prior testing performed by René Dupuis illustrates the reason why we look at cracking of the membrane. The test sample is from laboratory exposure and the real-world sample is from an aged roof (not directly related to this study).

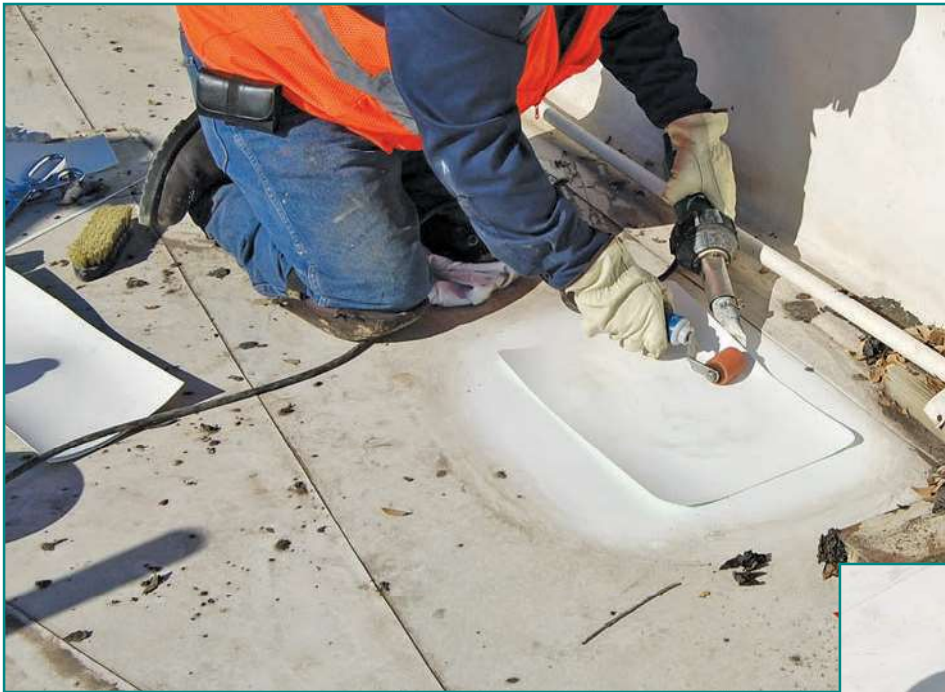
Figure 11 – Repair of aged TPO membrane with a new patch welded to the aged cap.
Image courtesy of WSRCA.

The ply adhesion of the new membrane to the aged cap averaged 43 lbf/in. for 45-mil membranes and 47 lbf/in. for 60-mil membranes. For the new membrane welded to the aged core, the ply adhesion averaged 53 lbf/in. and 57 lbf/in. for the 45-mil and 60-mil membranes, respectively. Representative data are shown in *Figure 13*.

The ply adhesion values of new repair membrane to the aged TPO membrane are above the average ply adhesion value of 40 lbf/in. from the SRI study on new TPO membranes. This provides validity to the integrity of repairs to aged TPO membranes and the ongoing maintainability of these roofs.

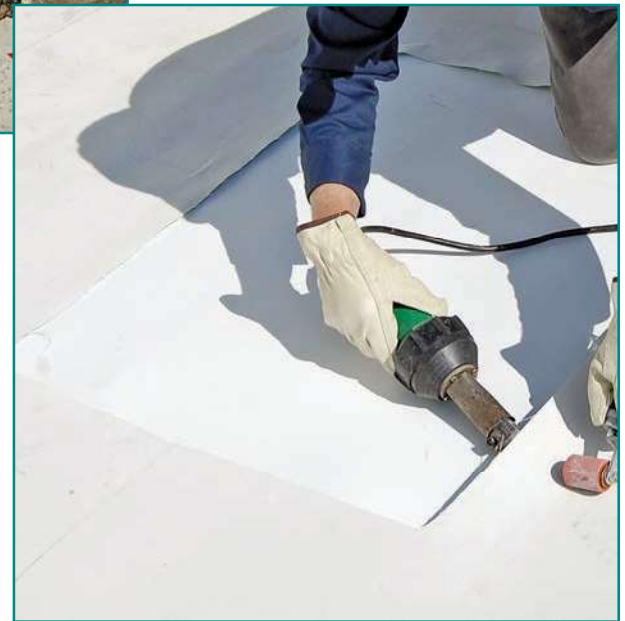
Figure 12 – Repair of aged TPO membrane with a new patch welded to the aged core.
Image courtesy of WSRCA.
