Performance Analysis of Aged TPO Membranes

**IIBEC 2020 Virtual International
Convention and Trade Show
June 12-14, 2020**

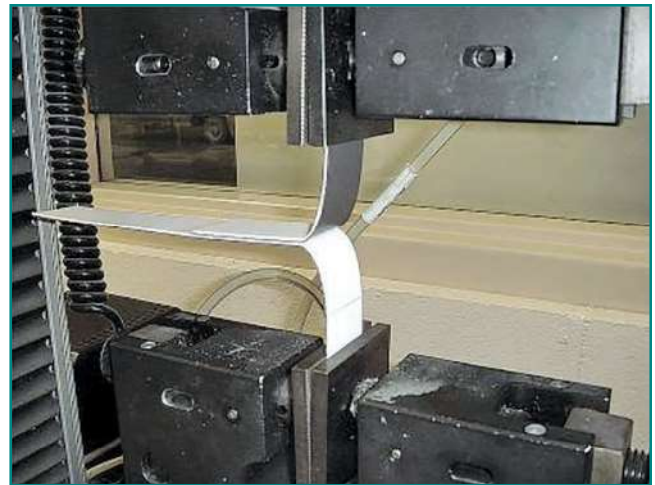
Figure 3 – The ply adhesion test in progress.

ASTM D1876¹², also referred to as the T-Peel Test, was used to evaluate the welded seam ply adhesion. The ply adhesion of the aged weld was tested, as shown in *Figure 3*. The initial peak load caused by breakage at the edge of the weld area, and the series of lower peak loads during delamination of the membrane, were recorded. The ply adhesion is calculated by averaging the load during the first five delamination events.

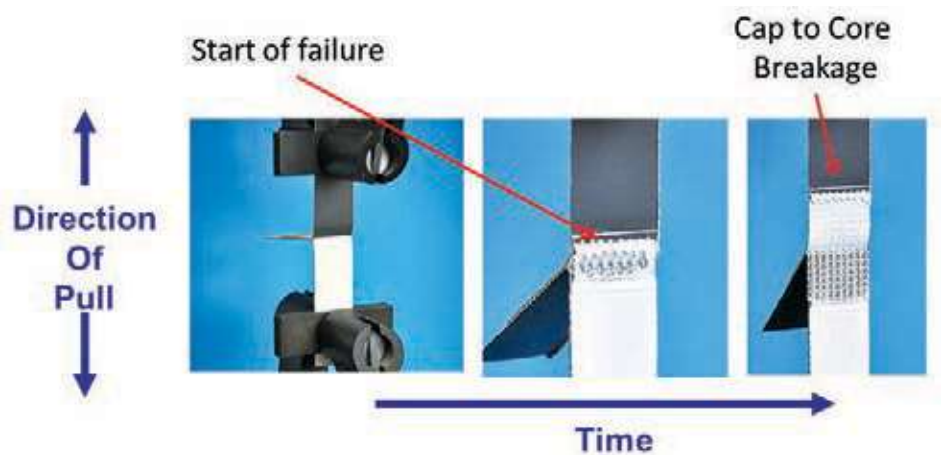
Ply adhesion testing of a proper weld will fail cohesively, exposing the underlying scrim. This is called a “film tearing bond” and is also used to evaluate the integrity of the weld. For the purposes of this evaluation, anything over 70 percent film tearing bond was considered a proper weld. *Figure 4* shows a 100 percent film tearing bond, indicating a complete and proper weld.

Figure 4 – Illustration of the ply adhesion test and a full film tearing bond, indicating a complete weld.
